# Manhole Inspection Summary

Manhole # S09EE2013MH

**Location** Address: **6000 GREEN MEADOW PKWY** Cross Street: **WESTERN RUN DR**

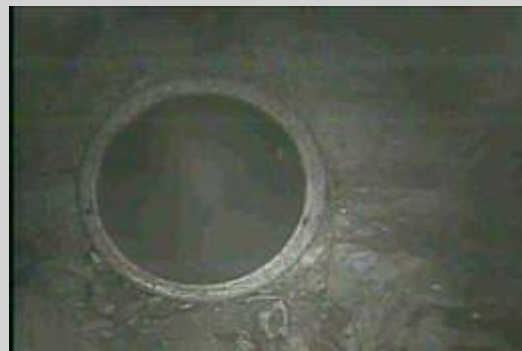
### Drop In @ 4 O'Clock

Drop: **Outside** Rod and Bar  
Angled: **Yes** Reading: **7.01** (ft.)  
Inv Depth: **8.01** (ft.)

Drop Condition: **Open**
